LAKE ST CATHERINE
AQUATIC VEGETATION MANAGEMENT PROGRAM
2012 ANNUAL REPORT

November 2012

Prepared by:
**Aquatic Control Technology, Inc.
11 John Road
Sutton, MA 01590**

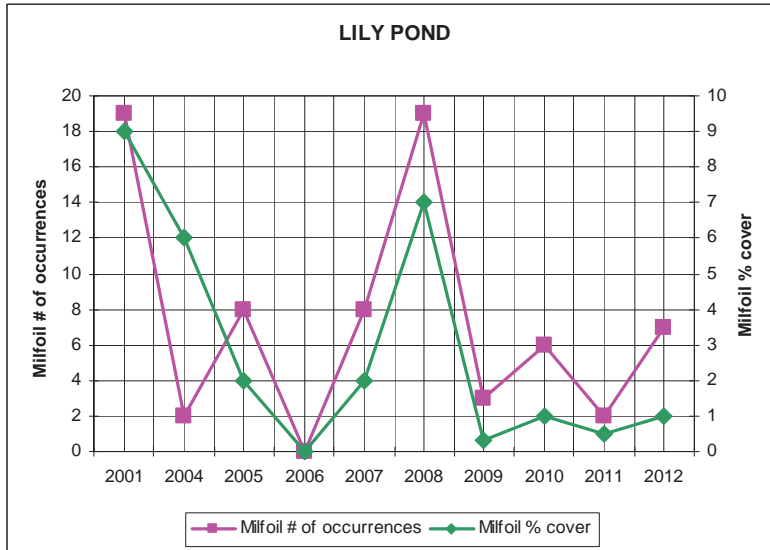
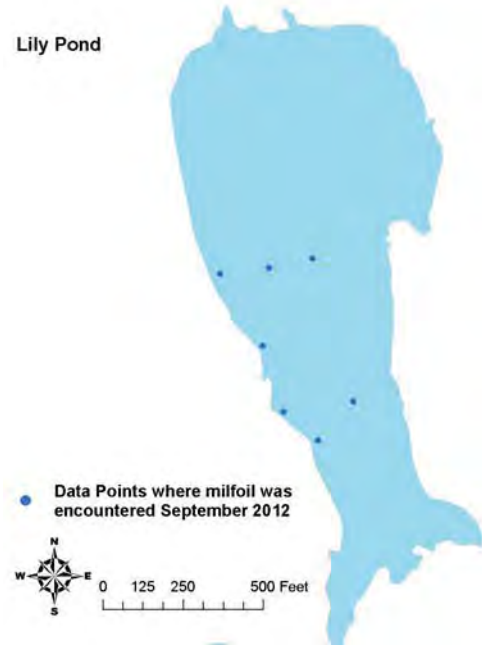
Chart 1: *Myriophyllum spicatum* Number of Occurrences and Percent Cover

Milfoil frequency in Lilly Pond increased significantly between 2011 and 2012 from just 8.3% to 29.2%; however, milfoil was only found at 7 data point locations. Despite the increase in frequency, milfoil growth remained fairly low density averaging less than 1% cover throughout the basin. Most of the milfoil encountered was found along the southwestern quadrant of the basin nearest the outlet to Lake St. Catherine. Milfoil was also notes in the channel area between Little Lake and the main basin.

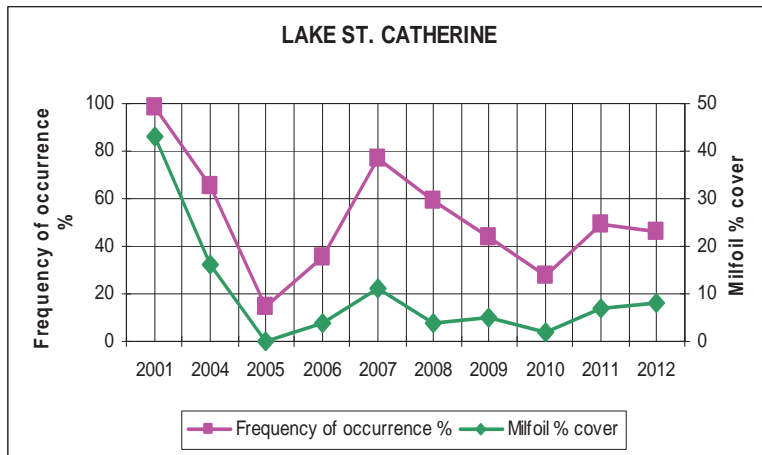
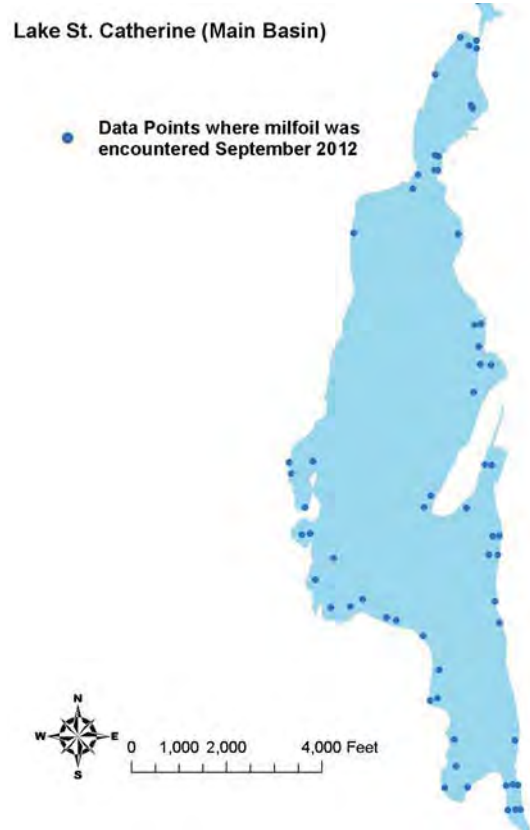
Chart 2: *Myriophyllum spicatum* Frequency of Occurrence and Percent Cover

Cover of *Myriophyllum spicatum* dropped slightly from 2011 from 49.6% to 46.5%, although average percent cover of milfoil did increase by roughly 1%. Scattered and sometimes moderate-dense growth of milfoil was also recoded outside the pre-established data points. Locations of milfoil were recorded with GPS are depicted in Figure 2. Milfoil was encountered at some of the data points located within 2012 treatment areas, but they were mostly individual stems or surviving plants found at the outer boundary of the treatment areas.

Chart 2 (below) represents year-to-year change in milfoil frequency and cover in the main basin.
