LAKE ST CATHERINE  
AQUATIC VEGETATION MANAGEMENT PROGRAM  
2013 ANNUAL REPORT

*October 2013*

*Prepared by:*  
Aquatic Control Technology  
11 John Road  
Sutton, MA 01590

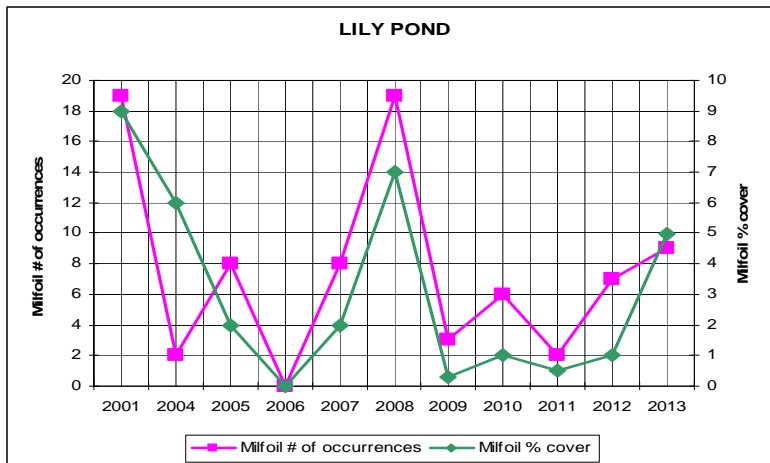
**Chart 1: Lily Pond: *Myriophyllum spicatum* Number of Occurrences and Percent Cover**

Milfoil FOC continued to increase between 2012 and 2013, rising to roughly 42%. Despite the increase (+12.5%), milfoil growth remained low density averaging less than 5% cover in the basin. Consistent with 2012, the most prominent growth of milfoil was in southwestern portion of Lily Pond. A few dense, topped-out patches were noted immediately abutting the western shore. Only scattered low density or singular milfoil plants were observed elsewhere in Lily Pond.

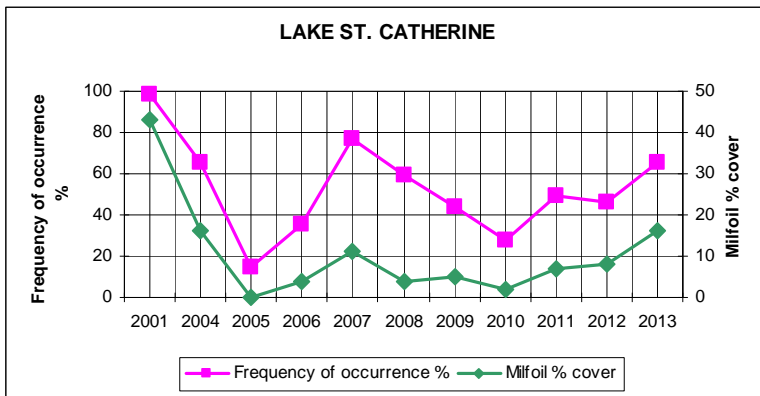
**Chart 2: *Myriophyllum spicatum* Frequency of Occurrence and Percent Cover**

Milfoil FOC increased notably between 2012 and 2013 from 46.5% to 65.6%. Relative percent cover of milfoil also increase and was the dominant species at over half (53%) of the locations where recorded compared to only 27% in 2012. Average cover of milfoil also doubled between 2012 to 2013 in the Main Lake increasing from 8% to 16%.

Chart 2 (below) represents year-to-year change in milfoil frequency and cover in the main basin.

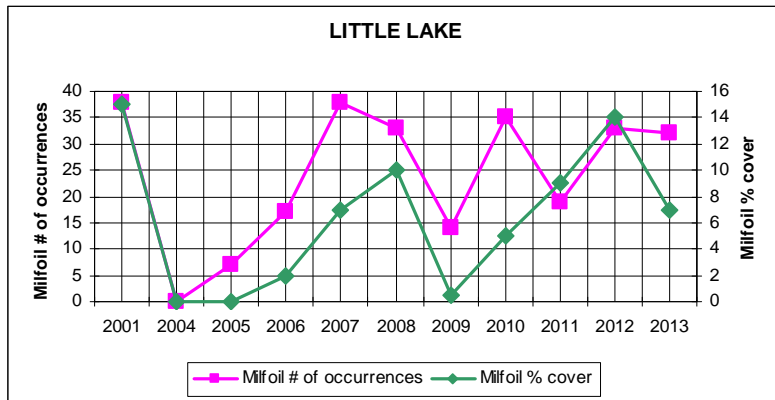
**Chart 3: *Myriophyllum spicatum* Number of Occurrences and Percent Cover**

Despite a reported mid-summer crash of *Myriophyllum spicatum* its frequency of occurrence remained high (~ 75%) in Little Lake. Where found, however, cover of milfoil was fairly low and was only the dominant species at 3 of the 32 locations where documented. Average milfoil density was also low at just over 6% estimated cover.

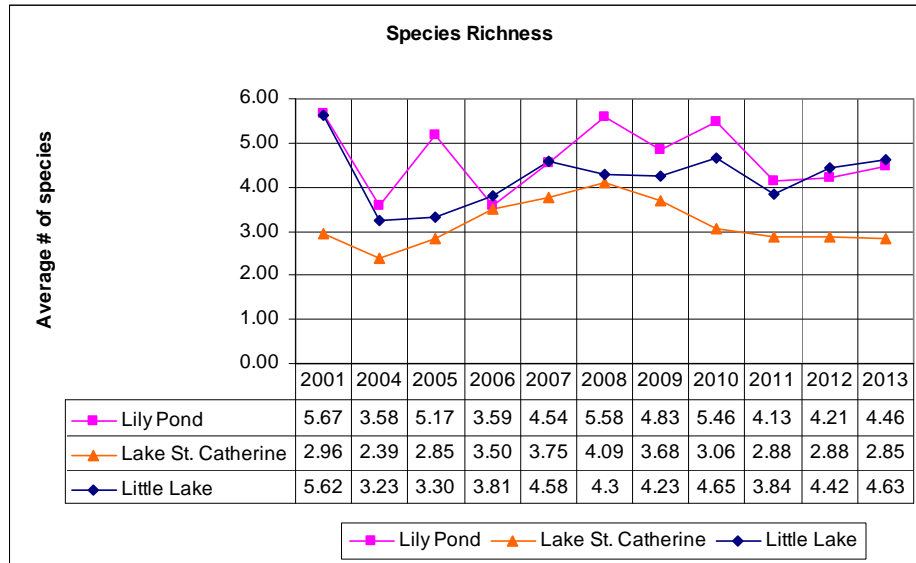
**Table 7: Species Richness by Basin**

Species richness in all three basins was consistent with findings from the past five years. It does not appear that the maintenance herbicide treatments or other management practices have adversely impacted species richness or native plant diversity.

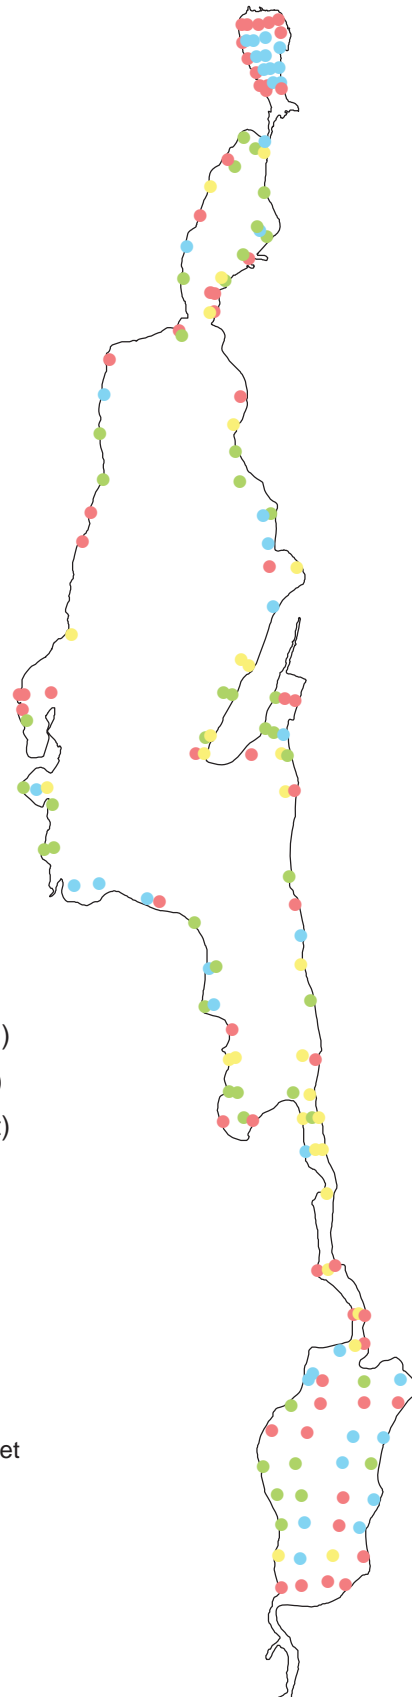
# 2013 TOTAL VEGETATION BIOMASS

Biomass indices reported during 9/24 & 9/25/13 survey

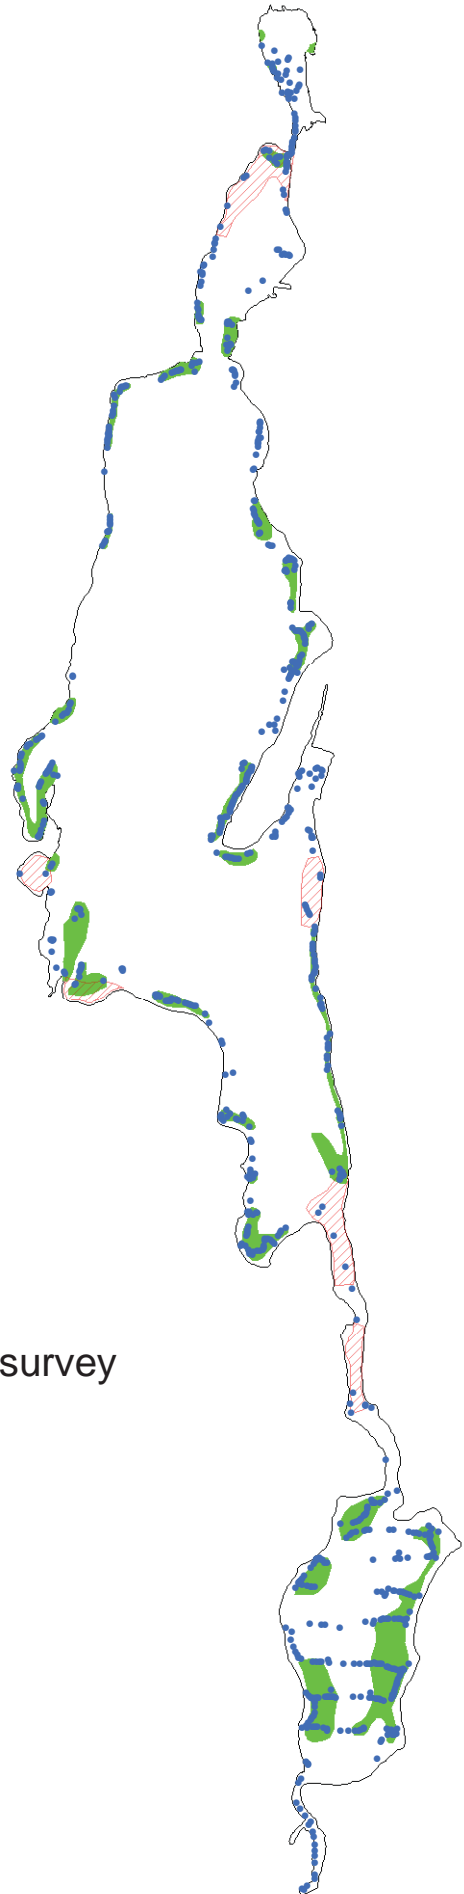
# 2013 Milfoil Distribution

- Locations of EWM growth recorded during Sept 2013 survey (includes pre-established survey points where EWM was encountered)
- EWM beds observed during Sept 2013 survey
- ▨ 2013 Treatment Areas
